INDOOR AIR QUALITY POST-OCCUPANCY ASSESSMENT

**Massachusetts Department of Transportation
Registry of Motor Vehicles
11 A Street
Edgartown, Massachusetts**

Prepared by:
Massachusetts Department of Public Health
Bureau of Environmental Health
Indoor Air Quality Program
April 2018

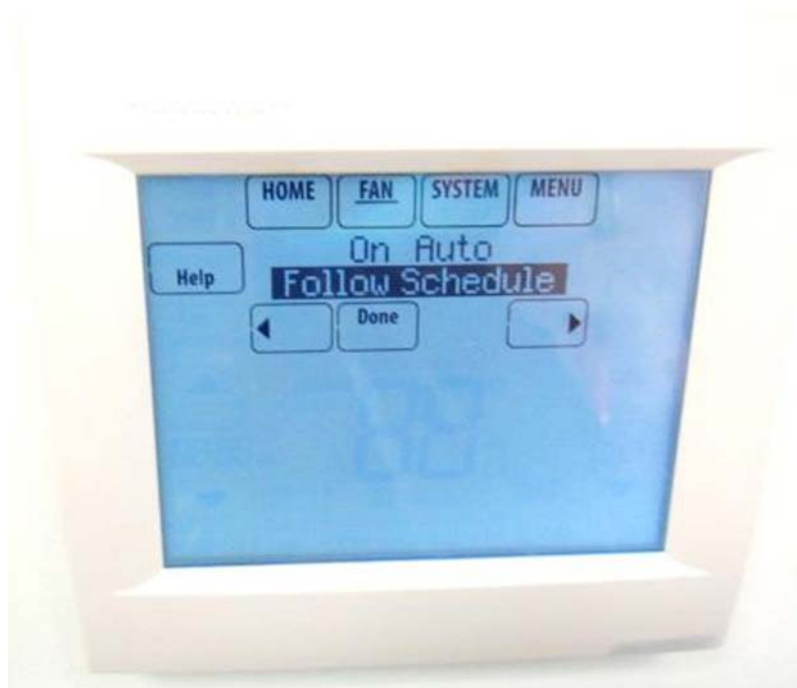
Picture 1

Digital thermostat note "on" and "auto" settings

2. Do not deactivate HVAC system. Consider operating in fan “on” mode to provide continuous circulation/filtration.
3. Contact HVAC engineer to confirm the location of the fresh air intake and determine if fresh air to RMV space can be adjusted/increased.

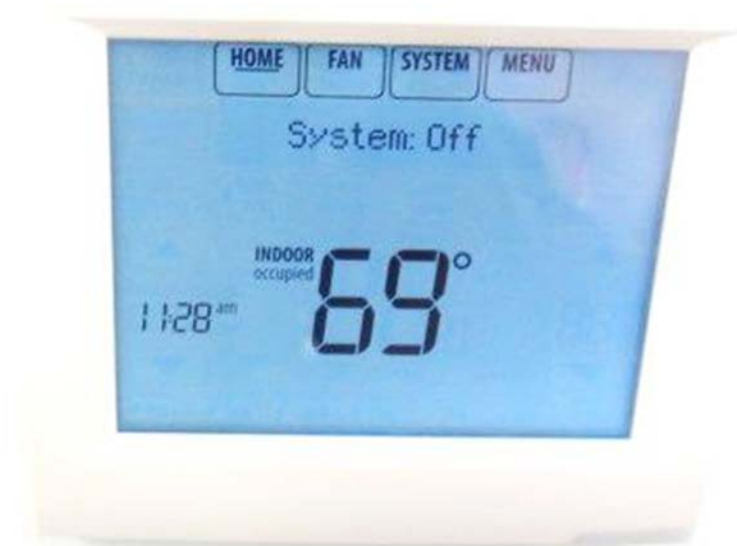
Picture 2

System deactivated "off" by RMV staff

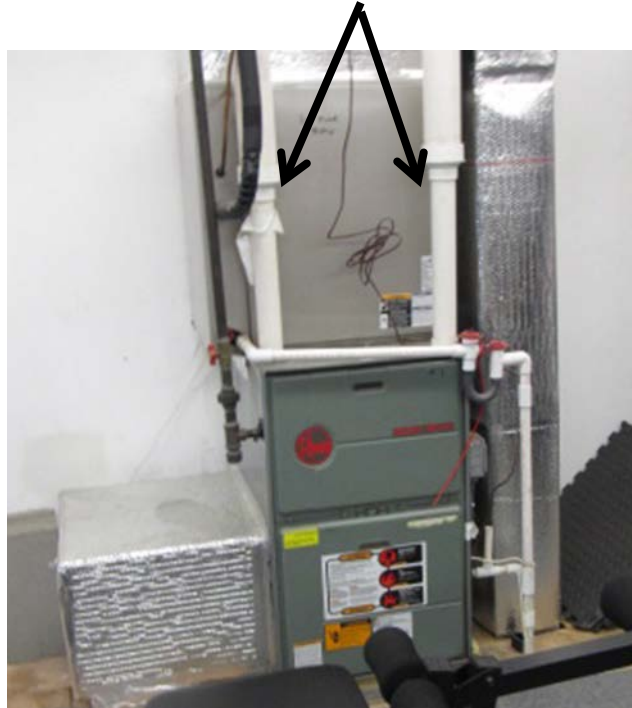
Picture 3

As mentioned previously, the elevated carbon dioxide levels (e.g., >800 ppm) shown in Table 1 indicate a lack of air exchange. The air handling unit (AHU) for the RMV space is located on the second floor. It appears that the RMV utilizes a high efficiency, sealed combustion AHU where combustion air and emissions are ducted via two PVC pipes that are installed through the roof (Picture 3). Conditioned air is delivered via ceiling diffusers (Picture 4) and returned to AHUs via wall-mounted return vents (Picture 5). At the time of the assessment, it could not be determined where the fresh air intake for the unit was located or whether the amount of fresh air introduction can be adjusted. Note that return vents have a toggle to adjust

Air handling unit for RMV located in gym on 2nd floor, note two PVC pipes (arrows) for combustion air supply and exhaust emissions

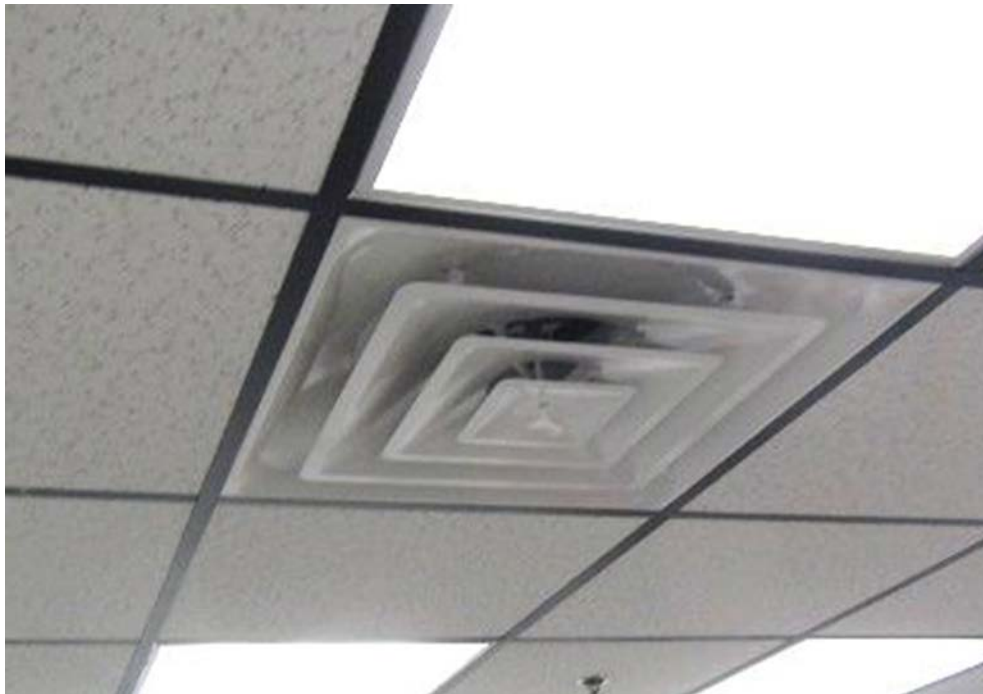
Picture 4

Typical supply diffuser

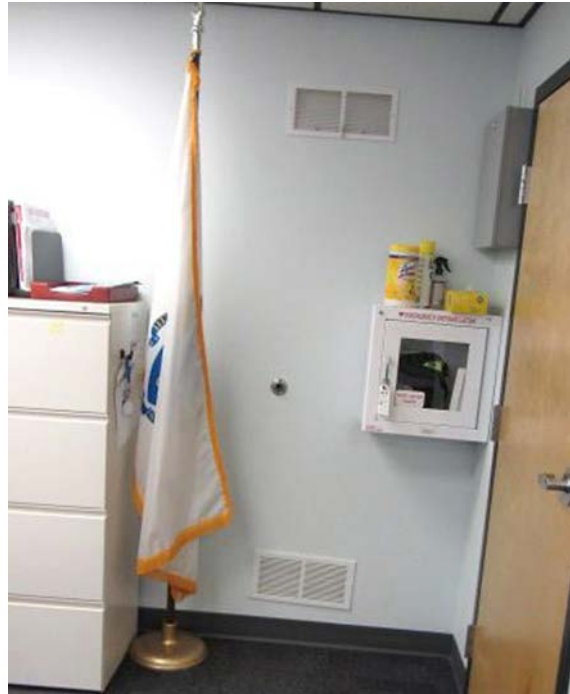
Picture 5

Wall-mounted return vents

4. Ensure wall-mounted return vents are adjusted to allow proper air exchange.
5. Install window screens so that windows can be used to supplement fresh air to the space and avoid insects from entering the building. Windows should not be opened during the operation of air conditioning to avoid condensation.

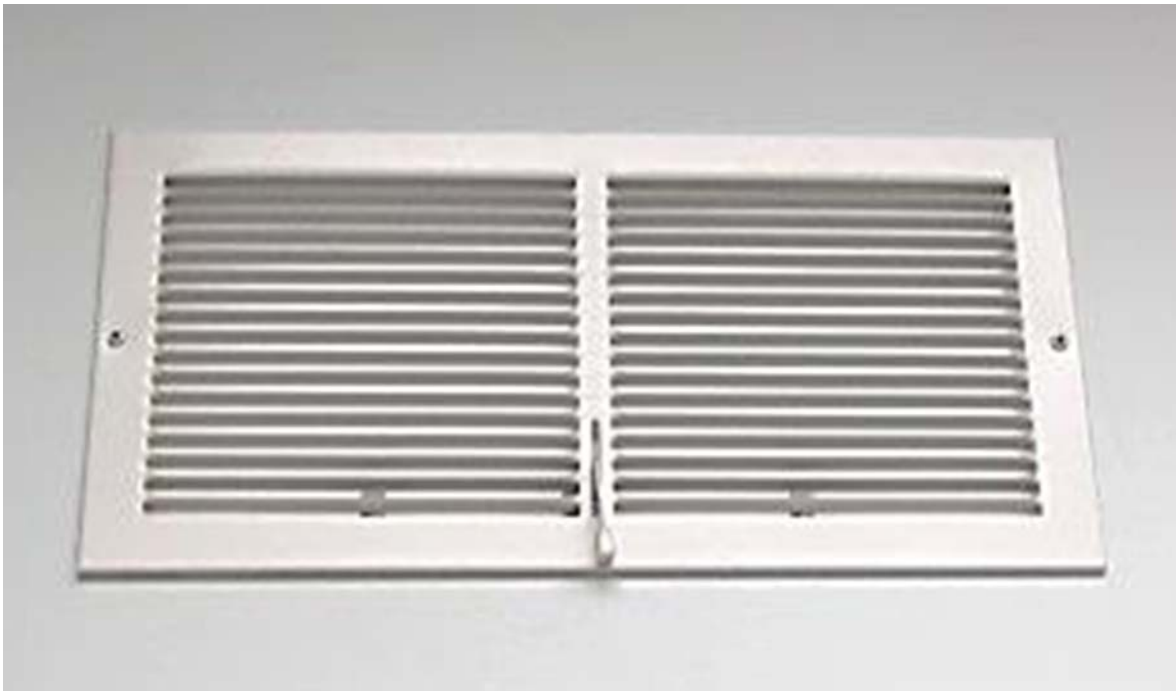
Picture 6

airflow (Picture 6); all vents were completely shut at the time of the assessment. These vents should be opened/adjusted to remove stale air/pollutants from occupied space.

Close-up of return vent, note lever to adjust airflow

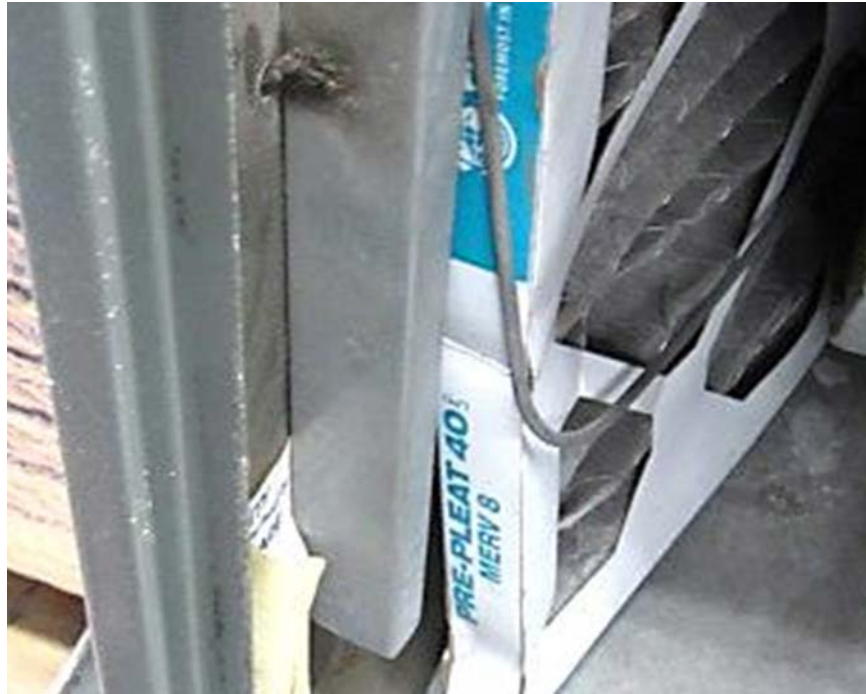
Picture 7

AHUs were outfitted with pleated filters of a Minimum Efficiency Reporting Value (MERV) of 8 (Picture 7), which are adequate in filtering out pollen and mold spores (ASHRAE, 2012). In addition, filters should be changed 2-4 times a year or in accordance with the manufacture's recommendations.

Pleated MERV 8 filter inside AHU for RMV

7. Continue with plans to change HVAC filters (using MERV 8 or higher filters) quarterly or as per the manufacturer’s instructions.
8. Clean carpeting annually or semi-annually in soiled high traffic areas as per the recommendations of the Institute of Inspection, Cleaning and Restoration Certification (IICRC, 2012).
